# Big Spring Creek Watershed Water Quality Restoration Plan and Total Maximum Daily Loads

**Public Review Draft**  
December 2004

Montana Department of Environmental Quality  
Water Quality Planning Bureau

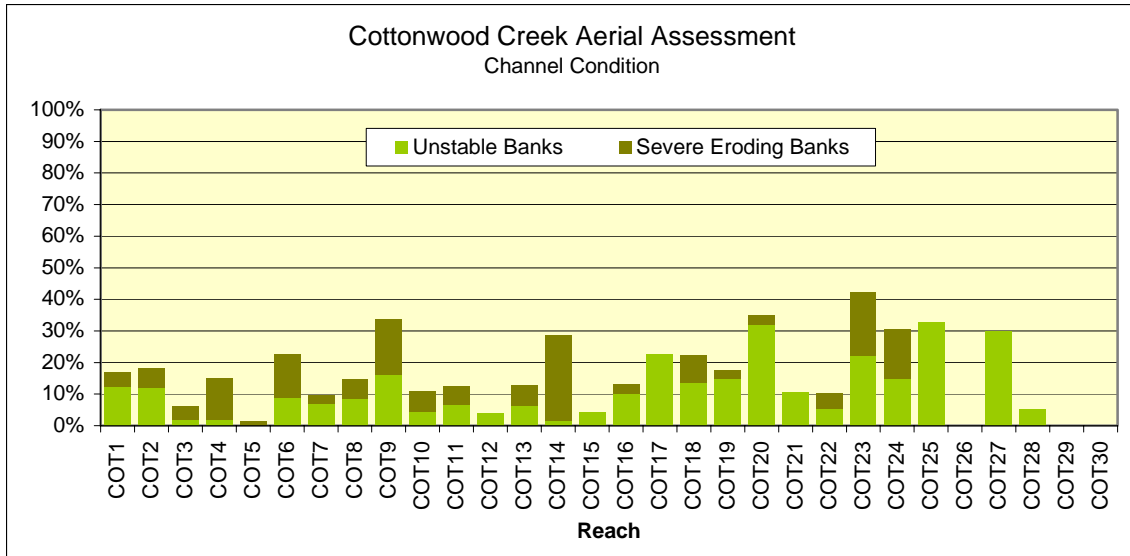
**Figure 4-33. Cottonwood Creek Channel Condition (Modified from Land & Water Consulting, 2003).**

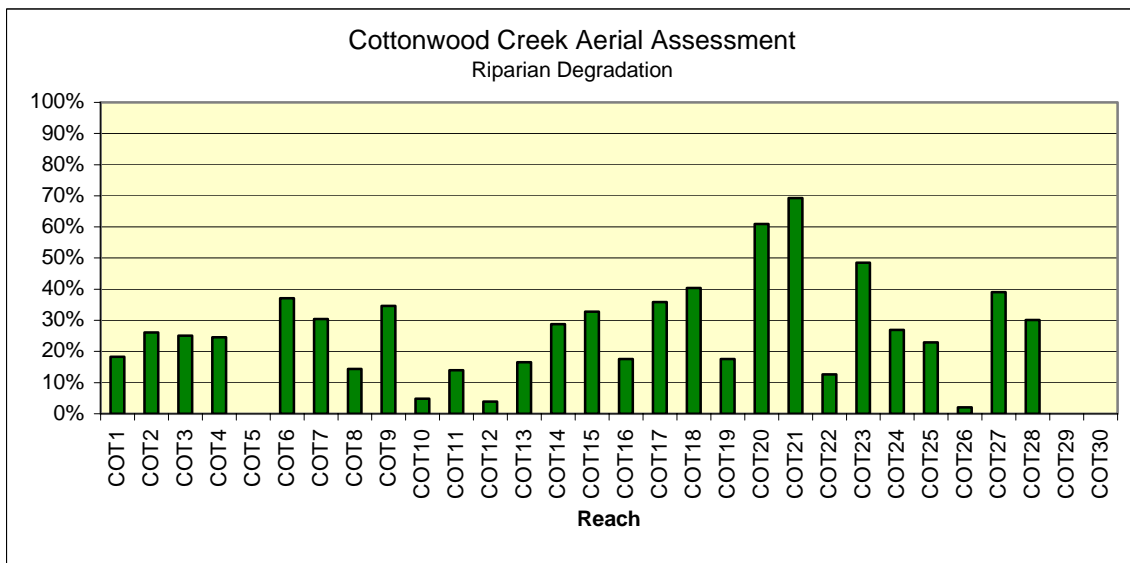
**Figure 4-34. Cottonwood Creek Degraded Riparian Vegetation (Modified from Land & Water Consulting, 2003).**

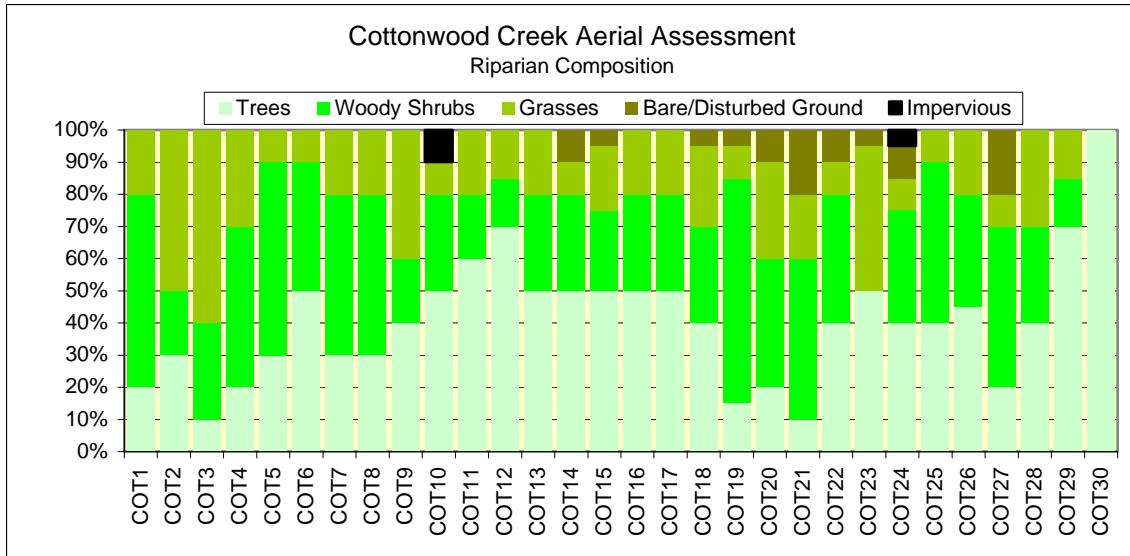
**Figure 4-35. Cottonwood Creek Riparian Composition (Modified from Land & Water Consulting, 2003).**

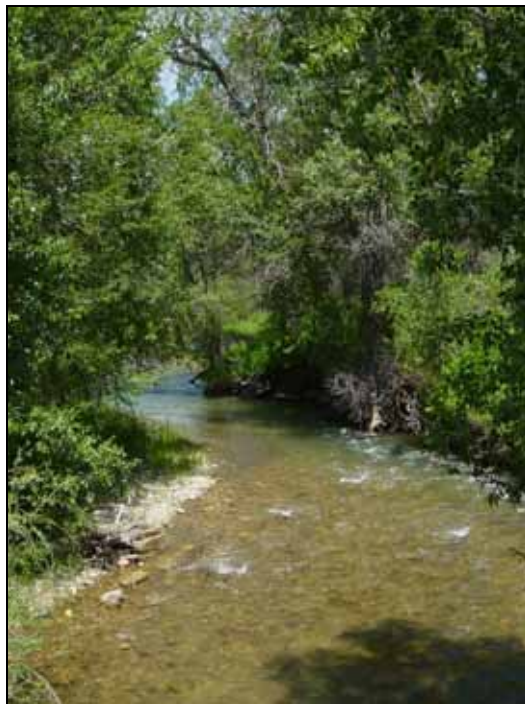
Based on this assessment, the percentage unstable banks and severe bank erosion on upper Cottonwood Creek, MT41S004\_051, was 12.9% and 3.9%, respectively. Riparian degradation ranged from 0% to 69% per reach with an average value of 25% for segment MT41S004\_051. Riparian vegetation composition is dominated by trees and woody shrubs and make up over 77% of the riparian cover on Upper Cottonwood Creek. Figure 4-36 illustrates a typical segment of Upper Cottonwood Creek, MT41S004\_051.

**Figure 4-36. Typical Riparian Condition of Upper Cottonwood Creek (COT18).**

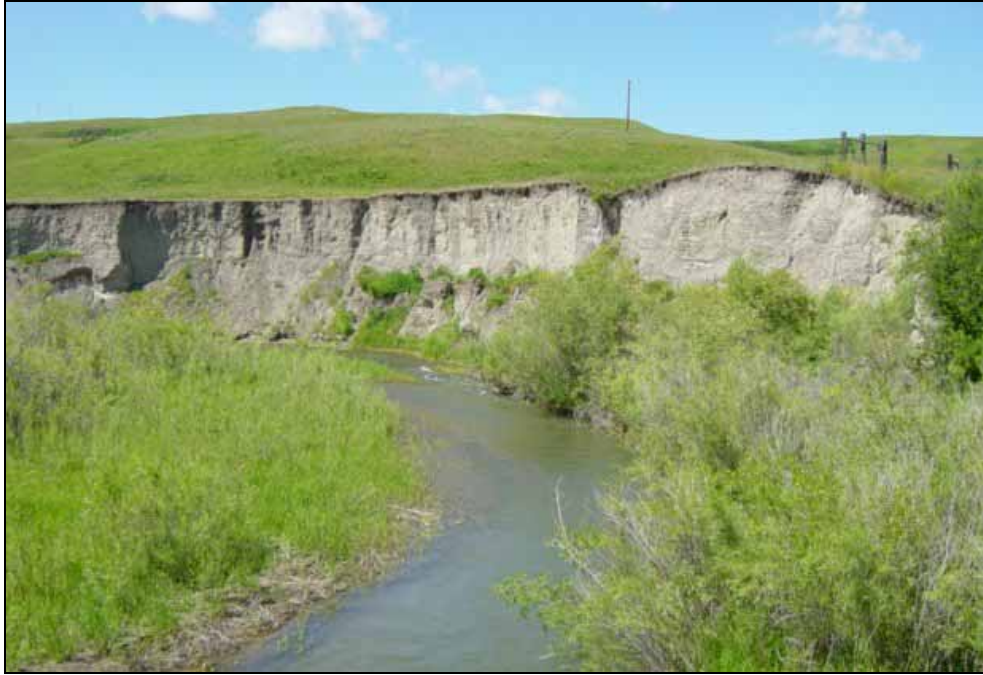
The percentage unstable banks and severe bank erosion on lower Cottonwood Creek, MT41S004\_052, was 6.5% and 6.7%, respectively. Riparian degradation ranged from 0% to 37% per reach with an average value of 20% for segment MT41S004\_052. Riparian vegetation composition is dominated by trees and woody shrubs and make up 75% of the riparian cover on lower Cottonwood Creek. Figure 4-37 illustrates a typical segment of lower Cottonwood Creek, MT41S004\_052 during spring flow conditions (June 21, 2003).

**Figure 4-37. Condition of Lower Cottonwood Creek (COT4).**

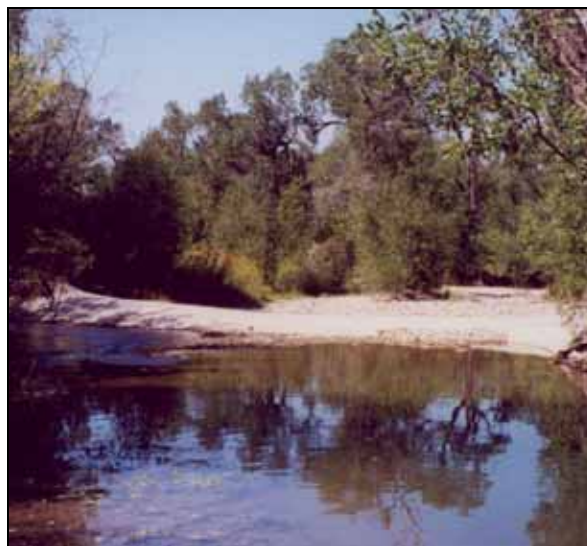
**Figure 4-39. Diversion Dewatering**

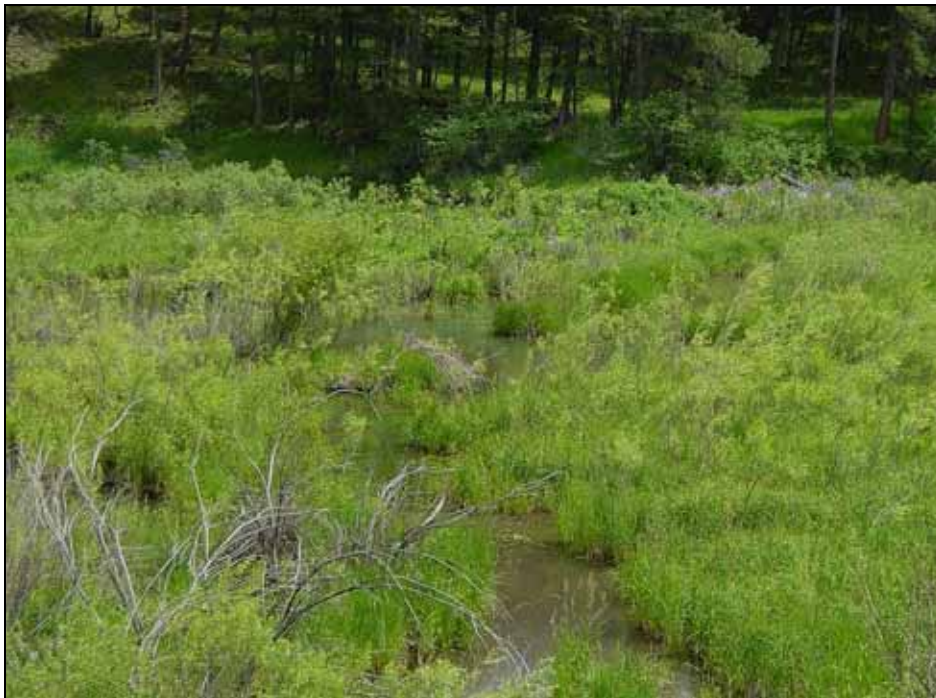
**Figure 4-44. Turbid water associated with beaver complexes (Casino Creek, 2003)**

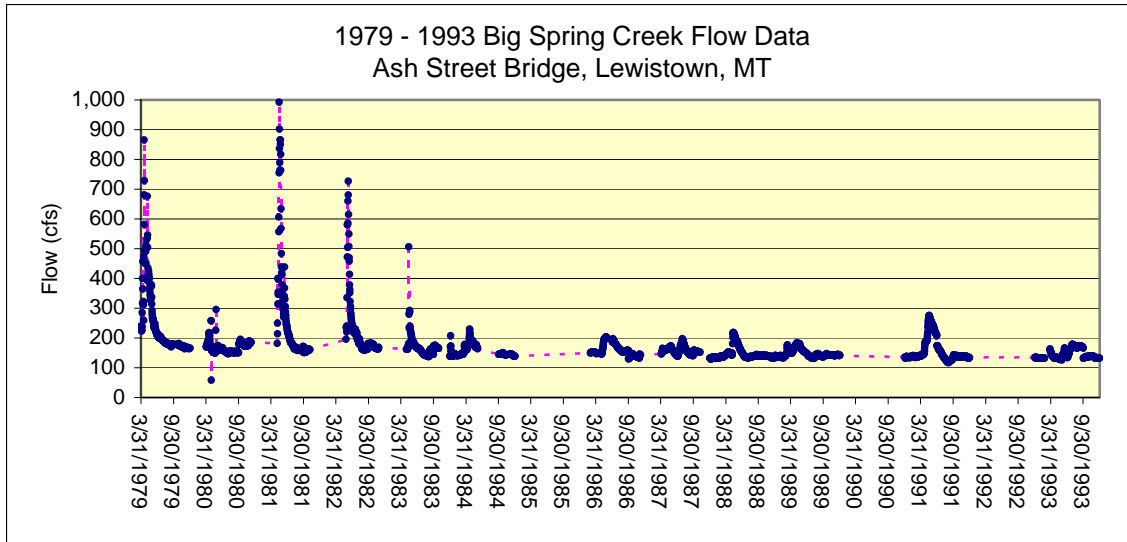
**Figure 5-2. Big Spring Creek Flows at Ash Street Bridge (DNRC Unpublished Data).**

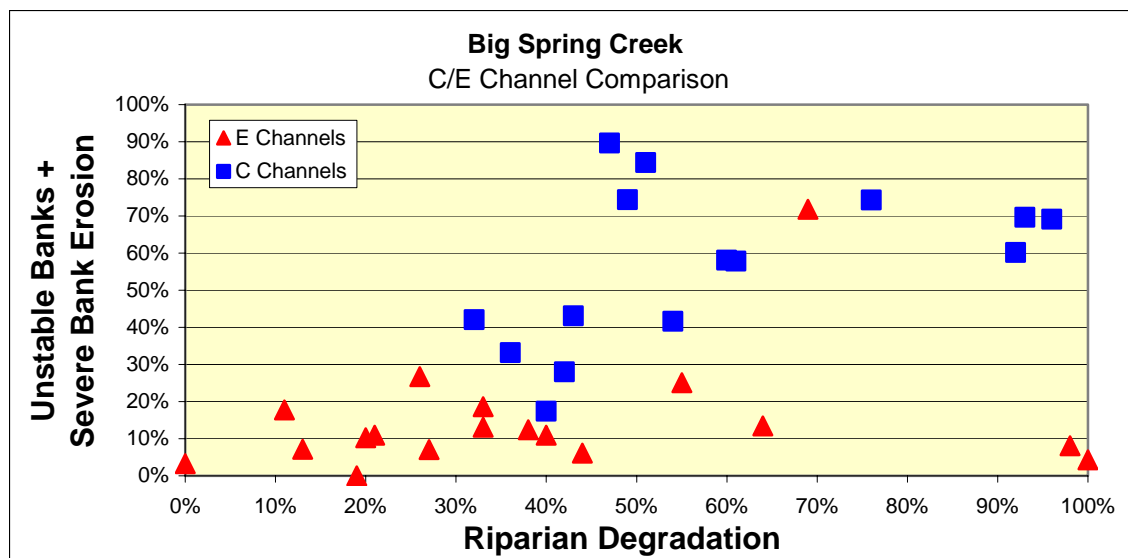
**Figure 5-6. Comparison Between C and E Channel Types in Big Spring Creek.**

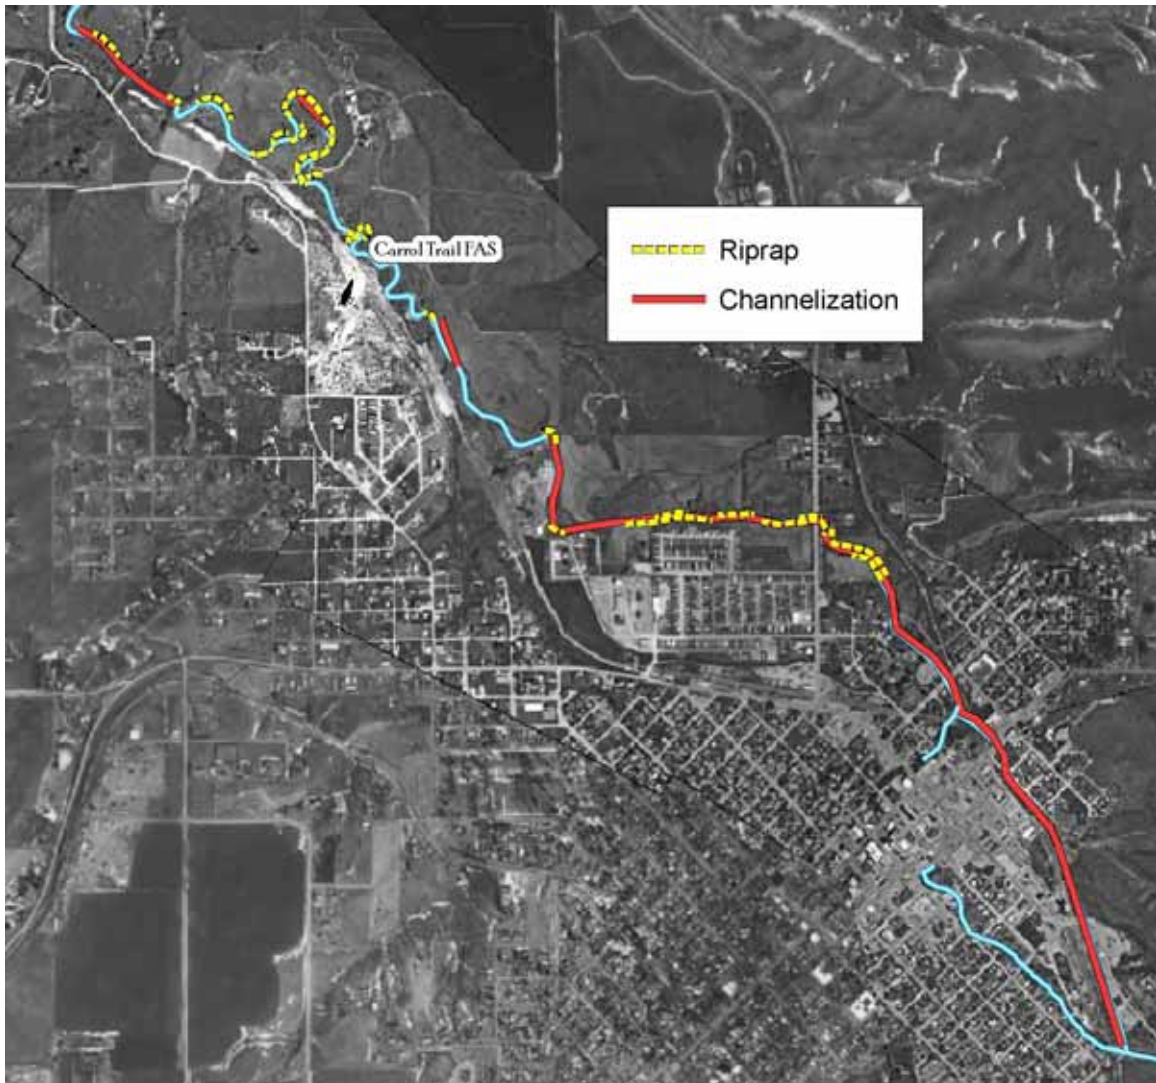
**Figure 5-7. Riprap and Channelization Through and Downstream from Lewistown.**

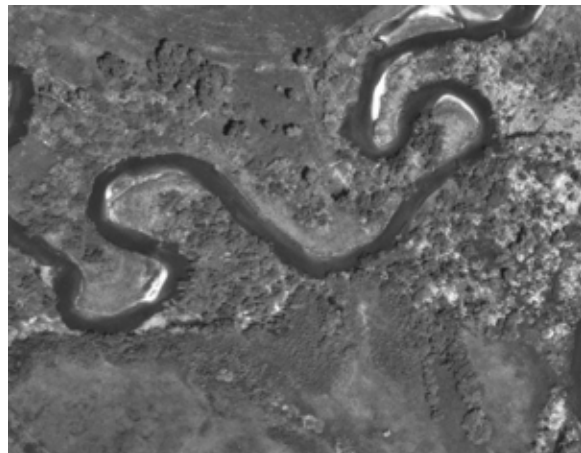
**Figure 5-9. Bank Stabilization with Native Vegetation.**

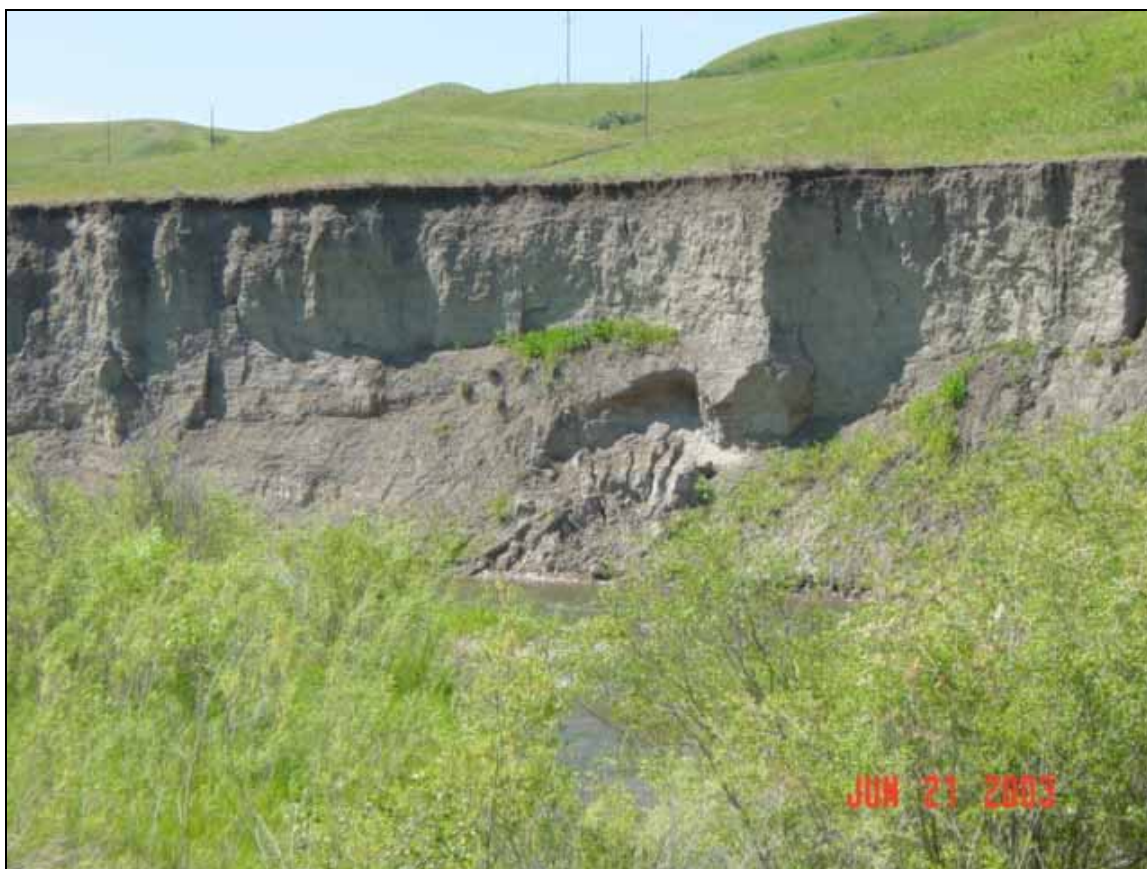
**Figure 5-10. Natural Erosion/Mass Wasting, Big Spring Creek Watershed.**

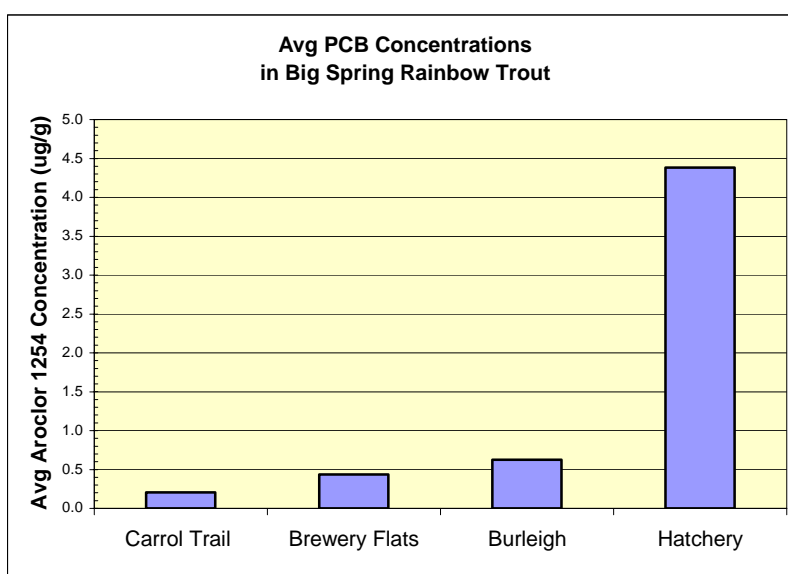
**Figure 6-4. October 2003 Fish Tissue PCB Concentrations.**

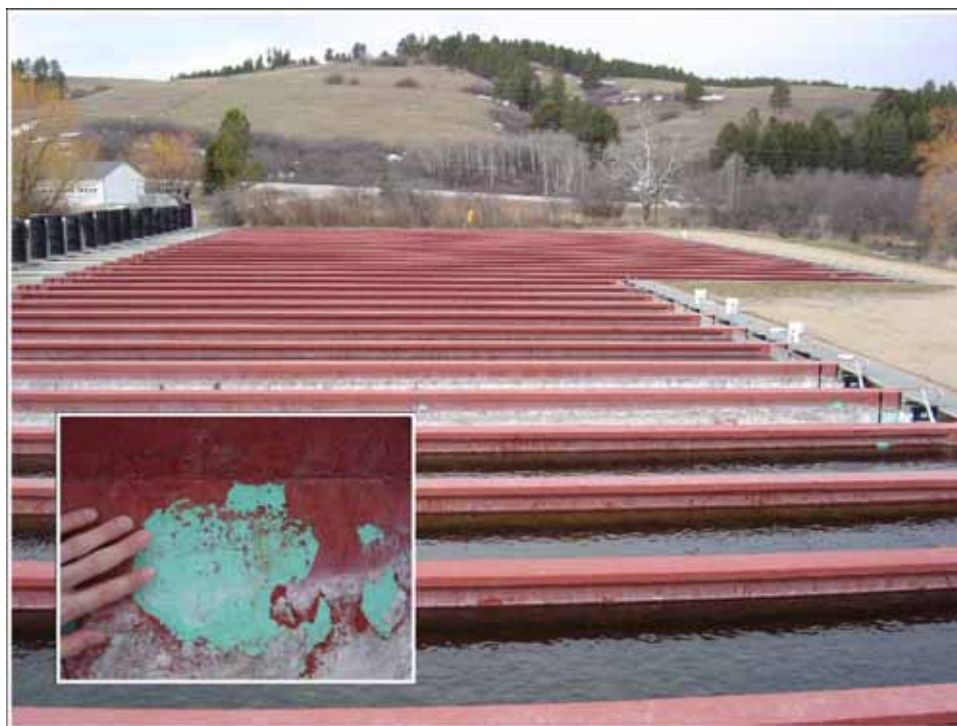
**Figure 6-7. Paint containing PCBs at the Big Springs Trout Hatchery – Lower Raceways.**

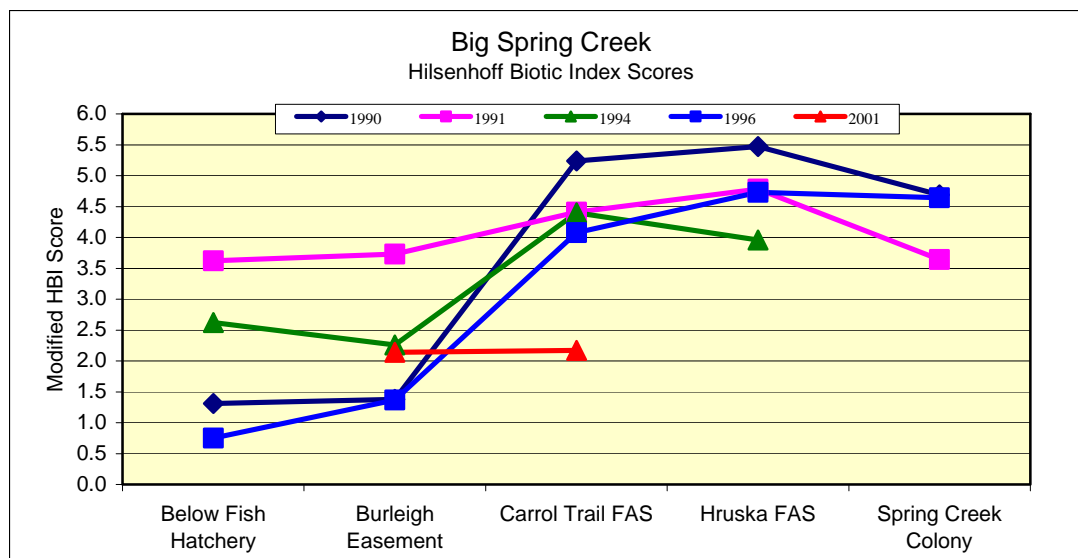
**Figure 7-1. HBI Scores for Big Spring Creek.**

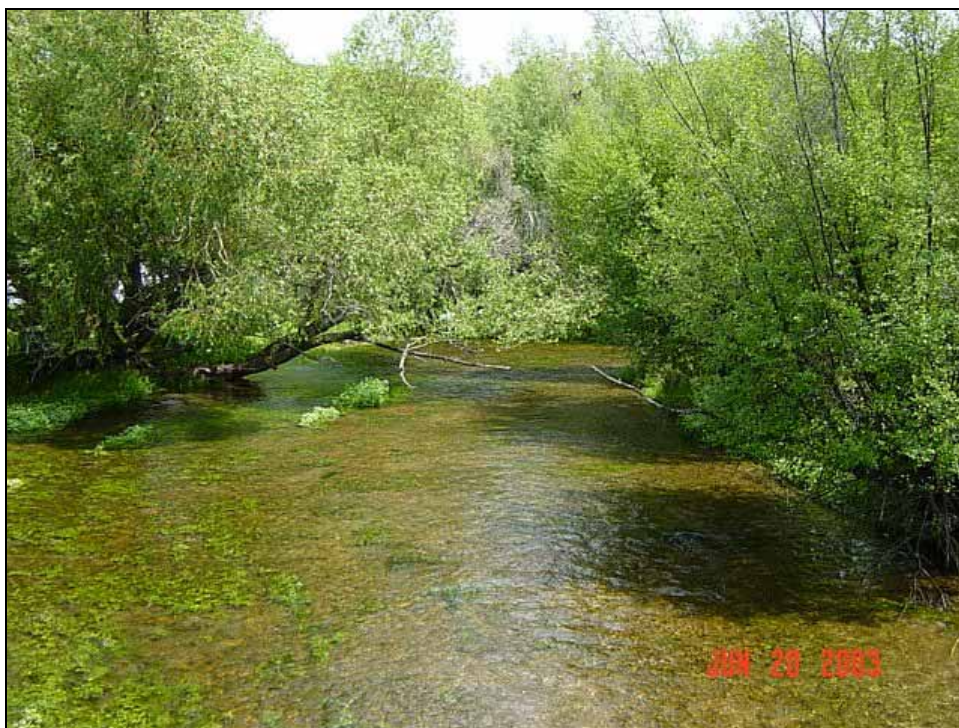
**Figure 7-2. Luxuriant Macrophyte Growth on Upper Big Spring Creek.**

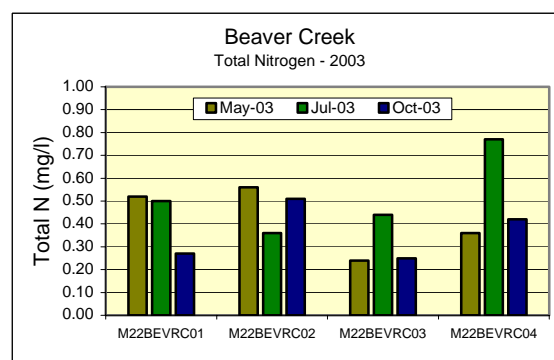
**Figure 7-8. Total N: Beaver Creek 2003.**

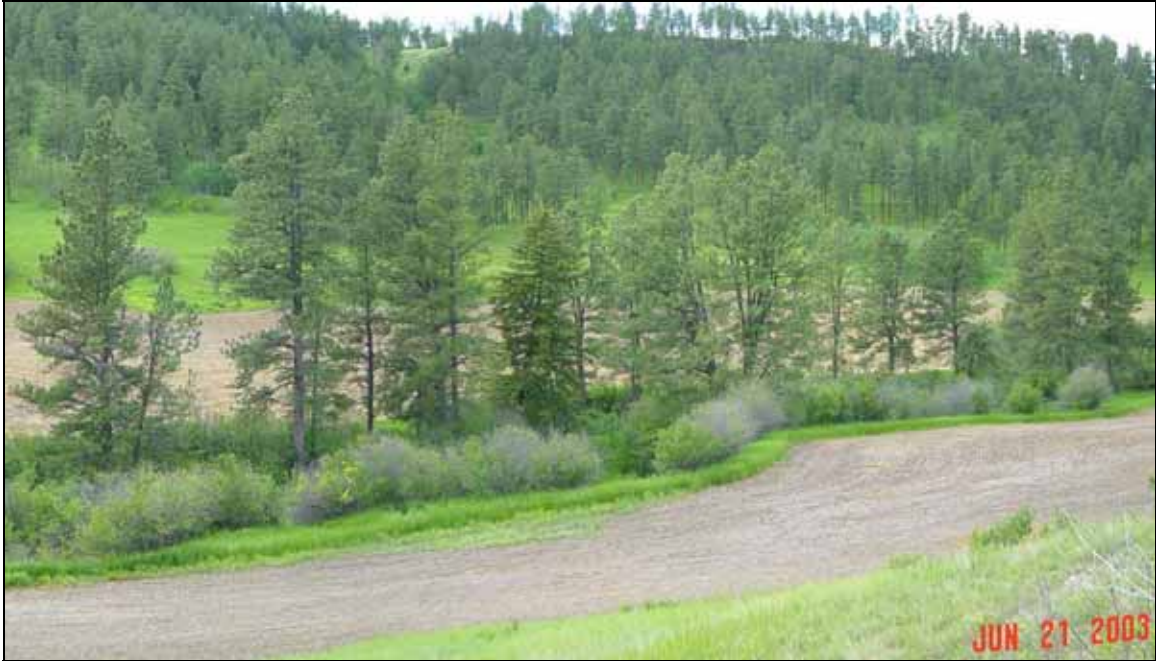
**Figure 8-5. Casino Creek Cropping near the Stream Channel.**
